# AMANAH MOTORS

## VEHICLE INSPECTION & CONDITION REPORT

| OVERALL RATING | STRUCTURAL | ROAD TEST | REPORT ID |
|---|---|---|---|
| 9.9 / 10 | CLEAR | PASSED | AM-INS-R<br>AIZE-001 |

| Vehicle Identity | |
|---|---|
| Make / Model | Toyota Raize |

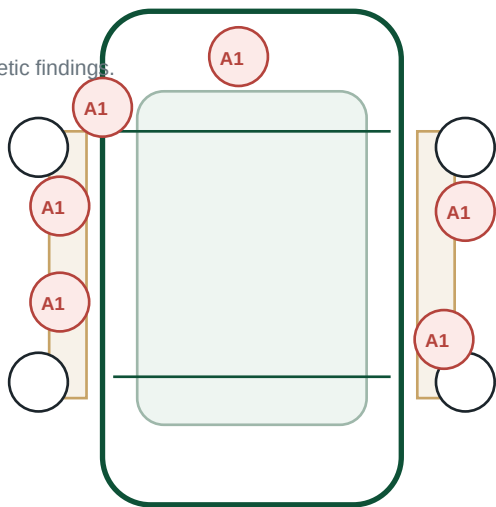
BODY CONDITION MAP

A1 = Small scratch  
Reference vehicle shows six A1 cosmetic findings.

| Panel / Area | Recorded Finding |
|---|---|
| Front Right Door | A1 - Small scratch |
| Rear Right Fender | A1 - Small scratch |
| Rear Left Door | A1 - Small scratch |
| Front Left Door | A1 - Small scratch |
| Front Left Fender | A1 - Small scratch |
| Bonnet | A1 - Small scratch |

**Amanah assessment:** No structural issue was recorded in the reference inspection checklist. Cosmetic observations are limited to minor A1 scratches on six panels.
